KENNEBEC RIVER BASIN
MANCHESTER, MAINE

COBBOSSECONTEE LAKE DAM
ME 00096

PHASE I INSPECTION REPORT
NATIONAL DAM INSPECTION PROGRAM

NOVEMBER 1979

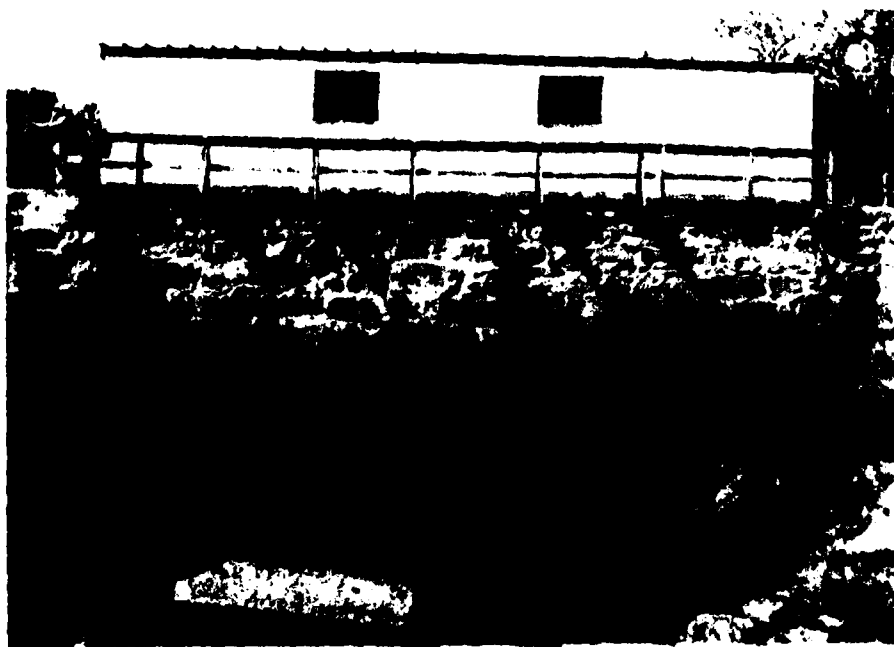
September 18, 1979
Figure 3 - Looking at the gatehouse and low-level outlets.

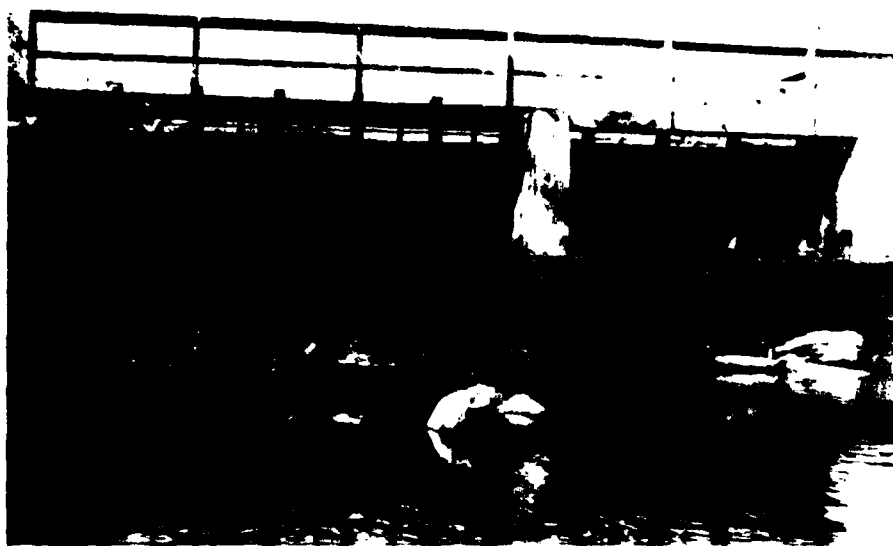
Minor deterioration of the concrete wood timbers and stoplogs in the stoplog spillway, if not corrected, could eventually lead to structural problems with the stoplog section of the spillway.

c. Appurtenant Structures. The stoplog spillway consists of two bays, 16 feet long, and 13 feet long, respectively, separated by a concrete pier. (See Appendix C - Figure 4.) The concrete in the spillway apron and the central pier is in good condition with only minor surface erosion which is limited to loss or surface laitance. Minor erosion, up to a maximum of one inch, has occurred at the base of the central concrete pier. (See Appendix C - Figure 7.) Minor surface erosion has occurred at the upstream end of the north end of the spillway structure exposing the coarse aggregate. (See Appendix C - Figure 8.) The stoplogs are supported by 10 vertical 6" x 10" timbers, which are somewhat deteriorated and appear to be untreated, except for the top ends of the timbers.

September 18, 1979
 Figure 4 - View of downstream face of the stoplog
 spillway.

(2) Replace the timbers and stoplogs in the spillway structure as needed.

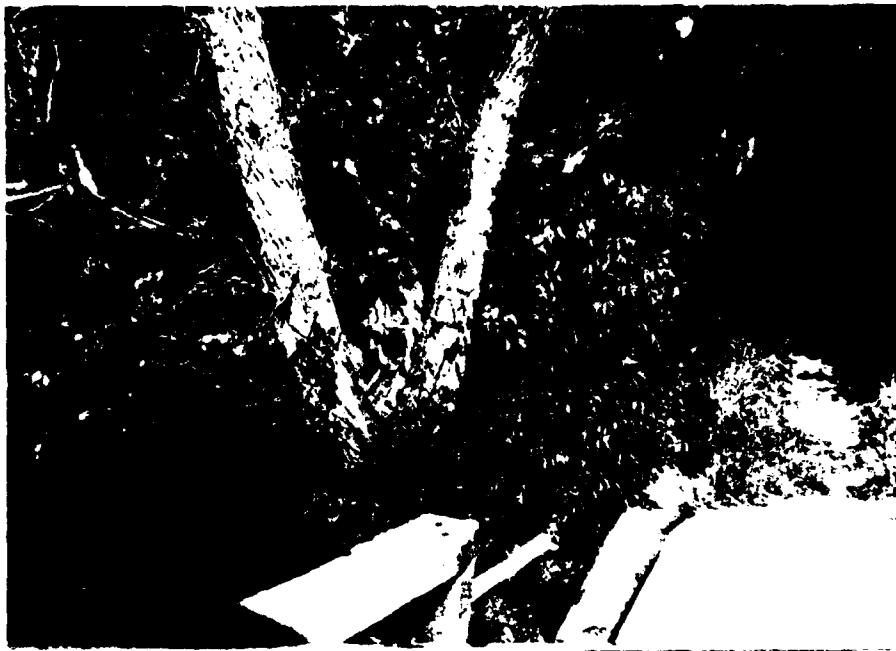
Trees and brush are growing from the earthfill that has been placed against the upstream and downstream faces of the stone masonry sections of the dam at the abutments. Growing roots of these trees may open up cracks in the stone masonry wall. If a tree blows over and pulls out its roots, or if a tree dies and its roots rot, seepage and erosion problems might result.

September 18, 1979
 Figure 6 - View of the large willow tree near the
 north abutment.

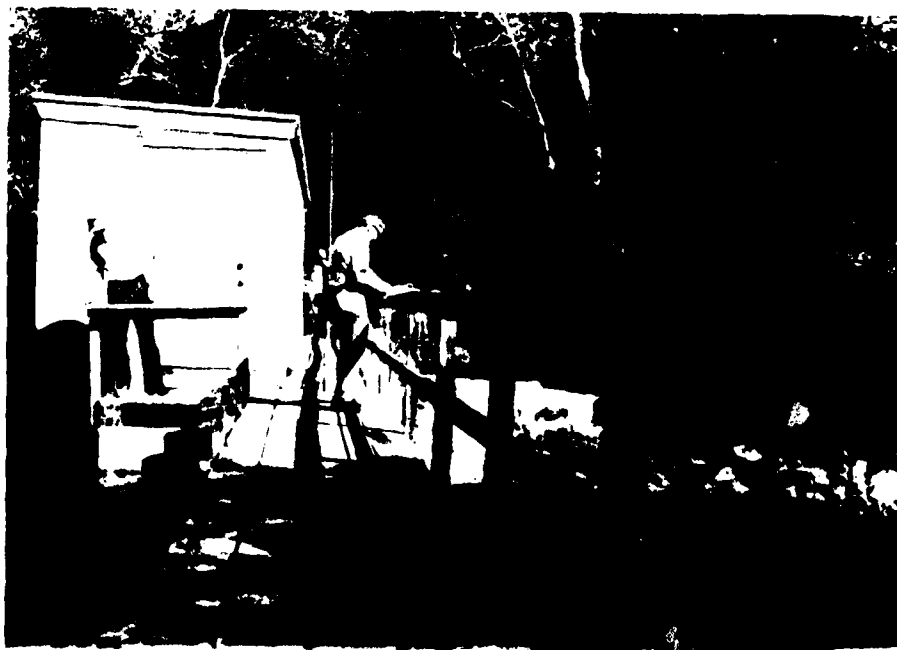
AREA EVALUATED	CONDITION
<u>OUTLET WORKS - SERVICE BRIDGE</u>	
a. Super Structure	
Bearings	None
Anchor Bolts	Steel-leaded into wood; surface rusted.
Bridge Seat	
Longitudinal Members	8x8 untreated wood; some surface deterioration observed
Underside of Deck	
Secondary Bracing	Wood timber used to support wood stoplog support; good condition
Deck	Wood plank - numerous areas of deterioration
Drainage System	Not applicable
Railings	Untreated wood; surface deterioration is limited
Expansion Joints	Not applicable
Paint	None
b. Abutment & Piers	
General Condition of Concrete	Good; minor undermining of concrete at base; some minor surface hairline cracks
Alignment of Abutment	No indication of movement
Approach to Bridge	Good
Condition of Seat & Backwall	Wood on mortar

September 18, 1979
 Figure 9 - Looking across the crest of the service
 bridge.

(3) Replace the deteriorated portions of the wood railings as needed and paint all railings.

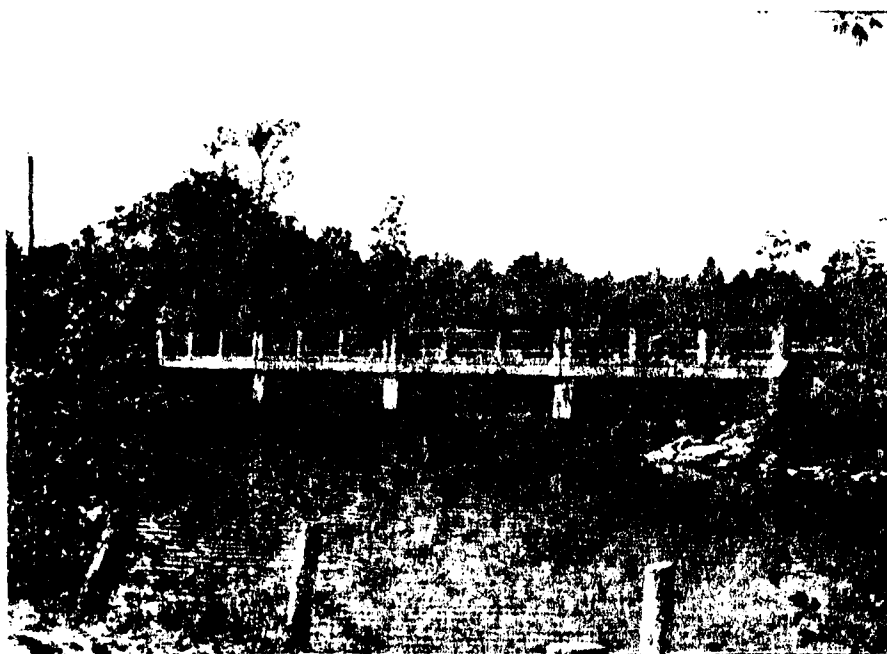
d. Reservoir Area. The watershed above the reservoir is moderately to steeply sloping and partially wooded. About 900 feet upstream of the dam a highway bridge crosses the approach channel. (See Appendix C - Figure 10.) Trees overhang both banks of the approach channel between the highway bridge and the dam. (See Appendix C - Figure 11.) Many camps are located on the shoreline of Cobbosseecontee Lake. No evidence of significant sedimentation was observed.

September 18, 1979
Figure 10 - Close-up view of the Pond Road bridge.

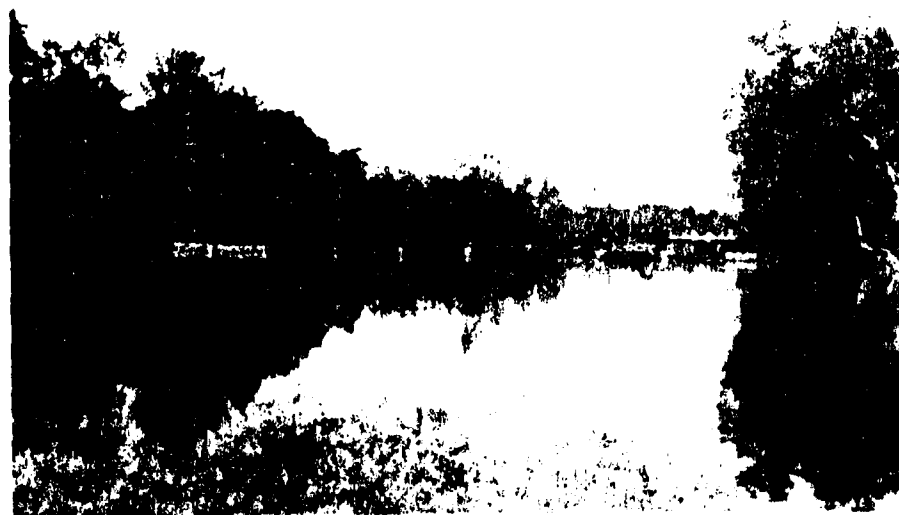
September 18, 1979
Figure 11 - Looking down the approach channel
from the dam.

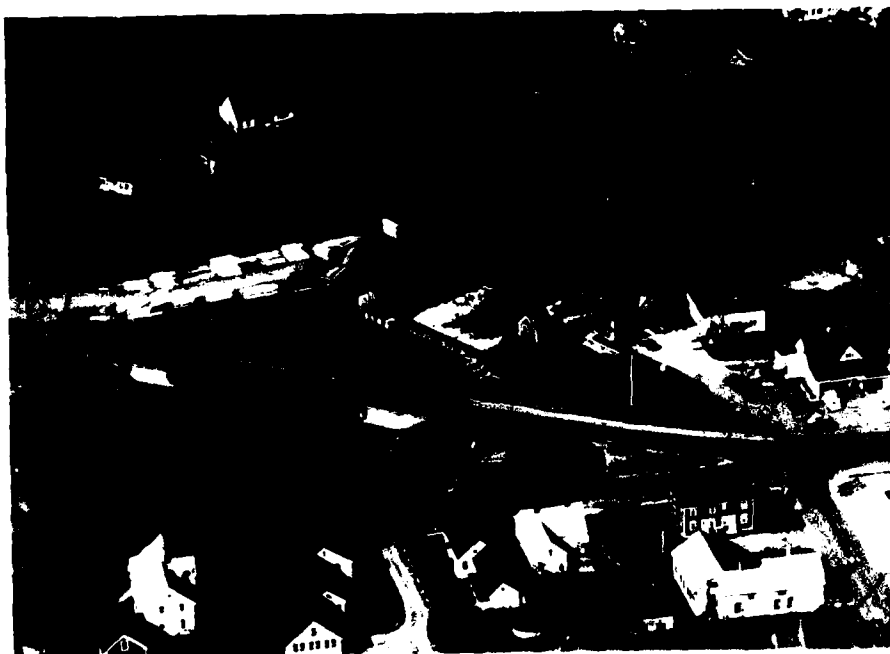
A stage discharge from Pleasant Pond, controlled by Gardiner Water District Dam, (See Appendix C - Figure 14.) was determined by use of the Corps of Engineers HEC-2 backwater computer program. It was determined that with a discharge of 3,250 cfs the elevation of Pleasant Pond would rise to 138.8' NGVD or 4.8 feet above normal level. This would cause backwater from the dam to the High Street bridge. The dam operators at Gardiner Water District Dam report no damage at elevation 138.1' NGVD (top of dam). The dam would be overtopped by 0.7 feet; damage would probably be minor. The 4.8-foot rise in Pleasant Pond would probably cause structural damage to cottages located on the shoreline; no loss of life is probable. Based on the above analysis, Cobbosseecontee Lake Dam was classified Significant Hazard.

October 1979
Figure 14 - Overview of the Gardiner Water District
Dam which impounds Pleasant Pond.
